# The performance of transmission pipelines on February 6th, 2023 Kahramanmaras earthquake: a series of case studies

E. Uckan<sup>1</sup> · M. Aksel<sup>1,2</sup> · O. Atas<sup>1</sup> · S. Toprak<sup>3</sup> · E. S. Kaya<sup>1,4</sup>

Received: 9 December 2023 / Accepted: 10 June 2024 / Published online: 1 July 2024  
© The Author(s) 2024

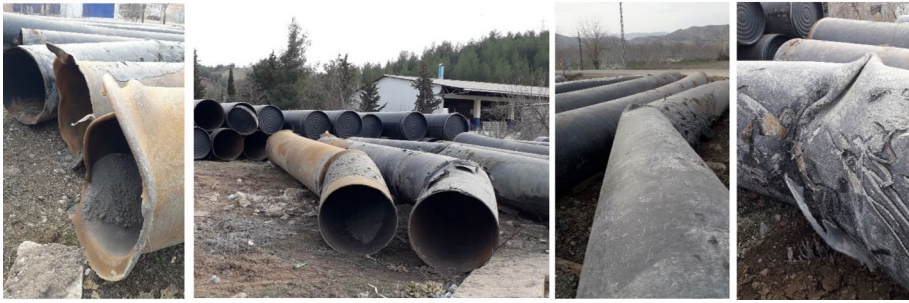
Due to PGDs major damage observed in NG pipelines. In many cases, especially under high compressive and tensile loads, wall tears, local buckling, wrinkles and reductions in pipe diameter occurred in the pipe wall despite of the high ductility of pipes as shown in Fig. 6. Pipe damage was also observed in smaller diameter steel NGs transmission pipes due to liquefaction induced lateral spreading in Golbasi (Fig. 7). Lateral spreads were measured up to 60 cm and caused damage mainly to the smaller diameter steel NG pipes in Golbasi region. Some pipes were buckled, broken, or separated due to weld failures as shown in Fig. 8.

When the compressive strains exceeded the limit state of the pipe, wall wrinkling (i.e. local buckling) occur. In such cases, even though the structure becomes unstable due to formation of plastic joints, the ductile pipelines might still be able to function. However, due to the possibility of fatigue failure during the operational safety of the pipeline may not be maintained in the long term.

**Fig. 6** Buckling and ovalization of the NG transmission pipelines collected from different fault crossing locations (See lidar file #SF1)

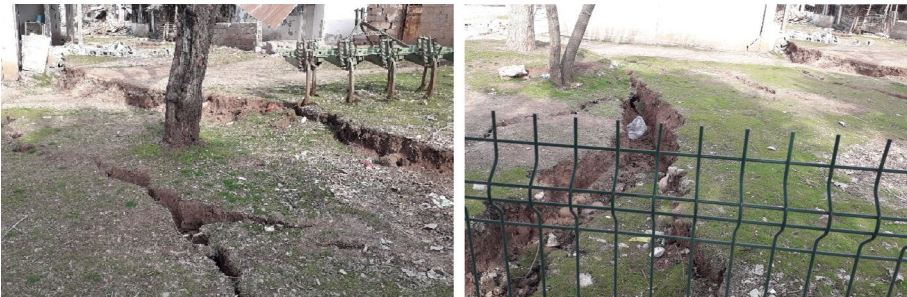
**Fig. 7** Liquefaction induced lateral spreading observed in Golbasi (see Fig. 1—zone 3 and Fig. 3)

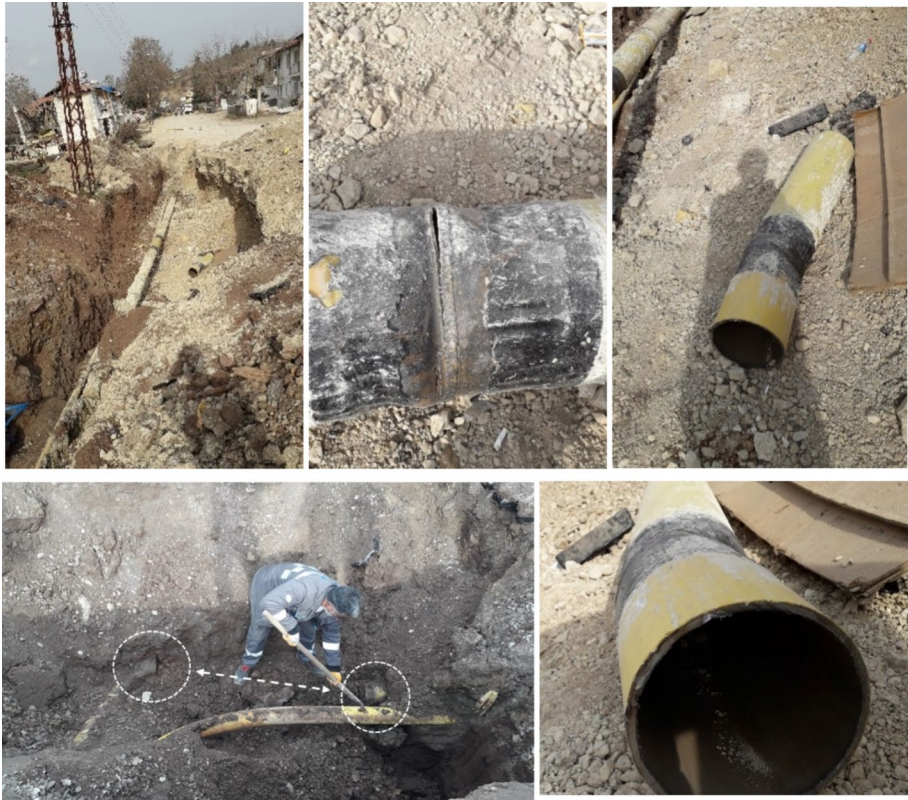
**Fig. 8** Weld failure and buckling of small diameter steel NG pipes due to liquefaction induced lateral spreading observed in Golbasi (see Figs. 1, 3 and 7). (See lidar files #SF2 and #SF3)

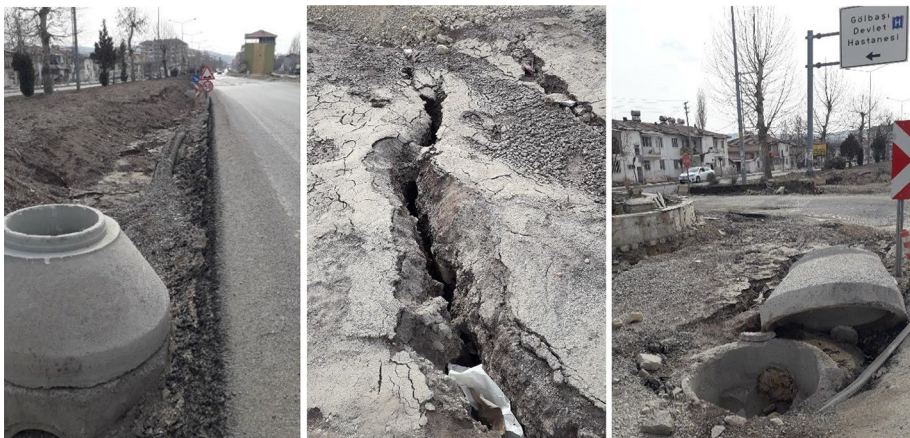
In addition to continuous steel lines, segmented wastewater pipelines were also seriously damaged due to sand boils as shown in Fig. 9. Due to excessive pore water pressure, upheavelling of sewage pipeline and floating manholes were observed in Golbasi. Their locations are shown in Figs. 1 and 3.

**Fig. 9** Upheavelling of sewage pipeline and floating manholes due to sand boils in Golbasi (See Figs. 1 and 3)

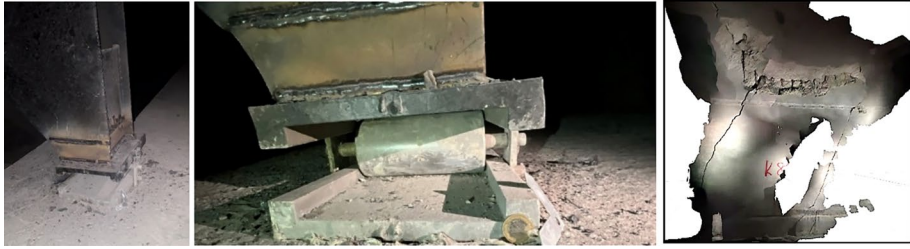
After the earthquake, the rollers were seen to display about 15.0 cm due to extension of the pipe. However, no damage was observed in the pipeline. On the other hand, the R/C lining, while protecting the pipeline from the tectonic action, was damaged at three points as shown in Fig. 14.

**Fig. 14** Displaced rollers and the damaged lining of the R/C tunnel (See lidar files #SF4 and #SF5)

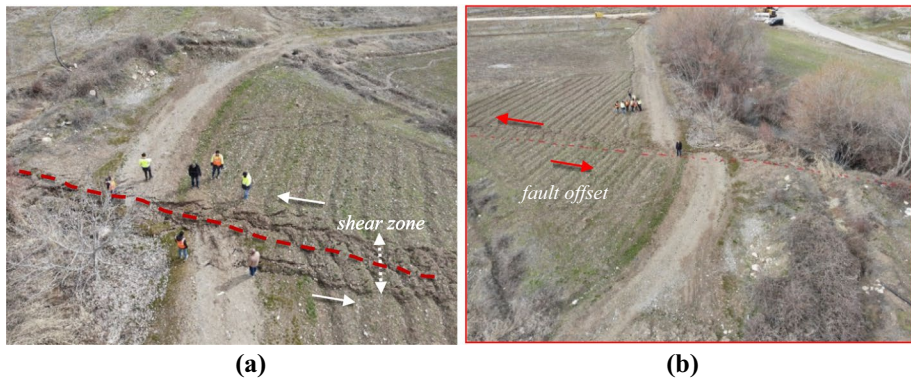
Due to excessive soil deformation (Fig. 16) caused by fault rupture, high compression loads mainly governed the circular cross-sectional shape, resulting in a change in the pipe's geometry to an oval shape (Fig. 17).

**Fig. 16** **a** The fault shear zone of the EAF in Sogutlu, **b** 4.0–5.0 m of fault offset nearby the Sogutlu fault crossing (Courtesy of GASKI)

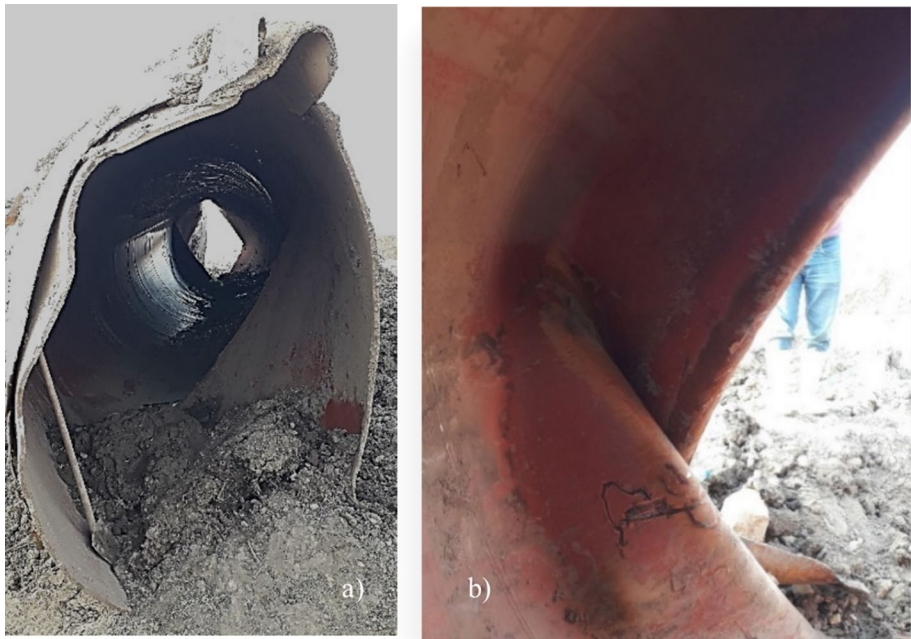
**Fig. 17** **a** Cross sectional distortion and ovalization and **b** wrinkling of the water transmission pipe

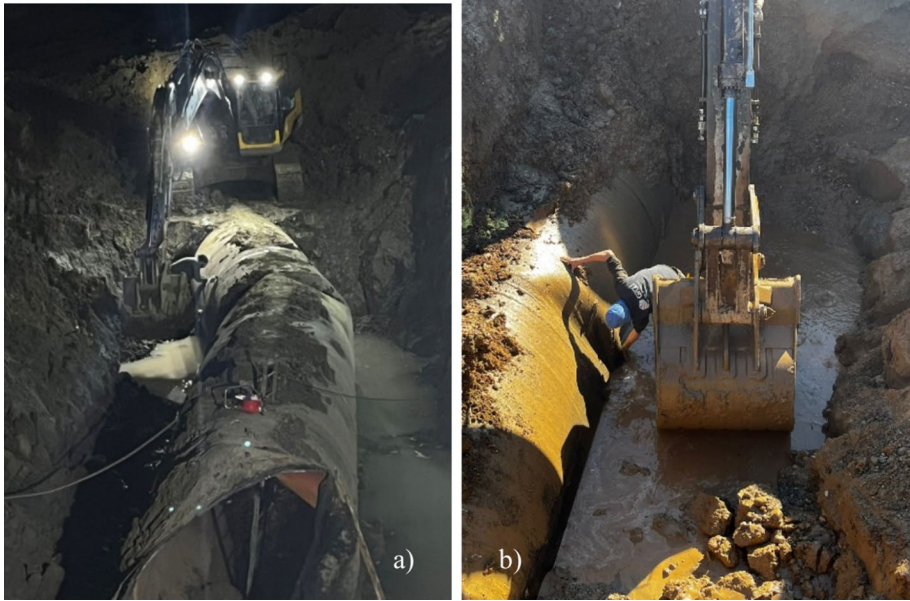
The overburden soil has been removed following the earthquake event in order to observe buckles and pipe damages (Fig. 18). According to the initial reconnaissance, there were four major wrinkles reported at the pipe bend which are two wrinkles at pipe bends, one in between these elbows and one another on the other side of the pipe. After

**Fig. 18** **a** Major (wrinkle) and **b** minor (local buckling) damages in the water pipeline (Courtesy of GASKi)

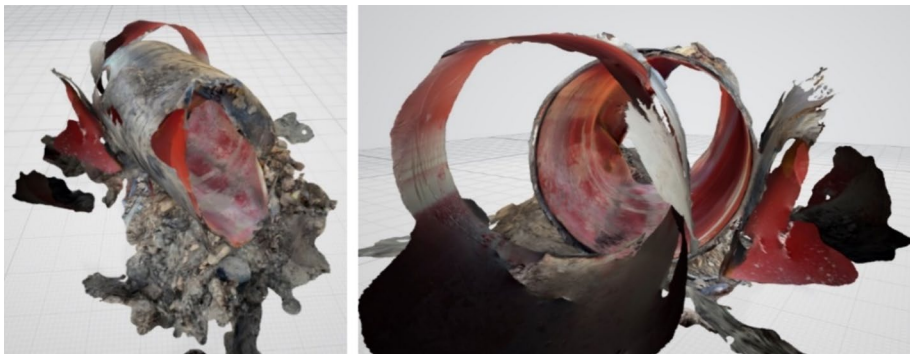
These damages can be seen in three-dimensional Lidar scans in Fig. 19, which show severe changes in the pipe wall, including wrinkling and ovalization damage states. Lidar measurements have also been made in other studies (Van Ballegooy et al. 2018). The replacement of the pipes took a couple of weeks. However no water shortage happened in Gaziantep as there were two more transmission lines that were operational (Fig. 20).

**Fig. 19** The 3D Lidar views of the damaged pipe wrinkling (See lidar files #SF6 and #SF7)

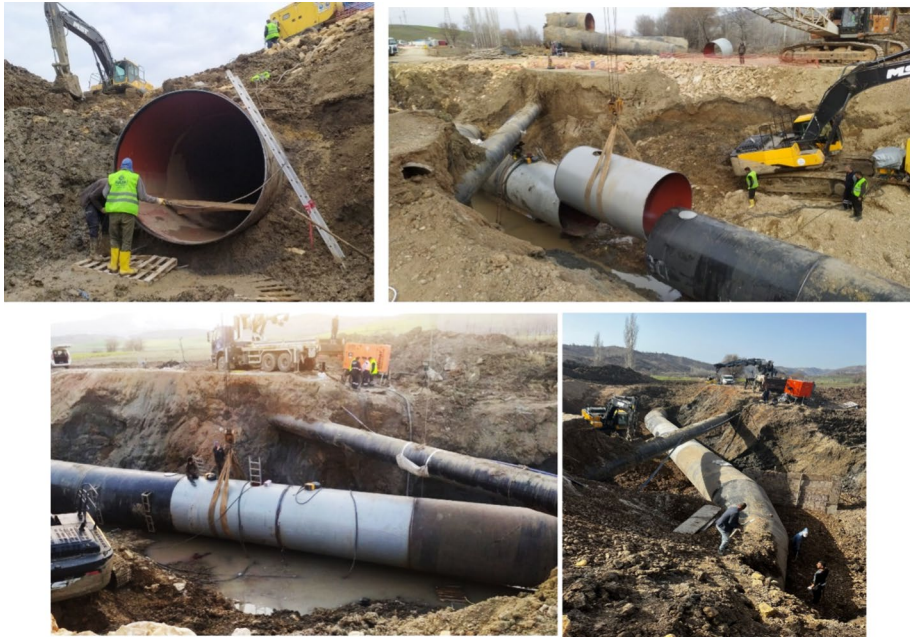
**Fig. 20** Replacement of the damaged sections of the water pipe crossing the NG pipe (Courtesy of Gaski)

the overburden soil had been removed, the pipeline was cut out and replaced by a new one (Fig. 20). Detailed lidar views (Fig. 19) of the damaged sections are also provided.

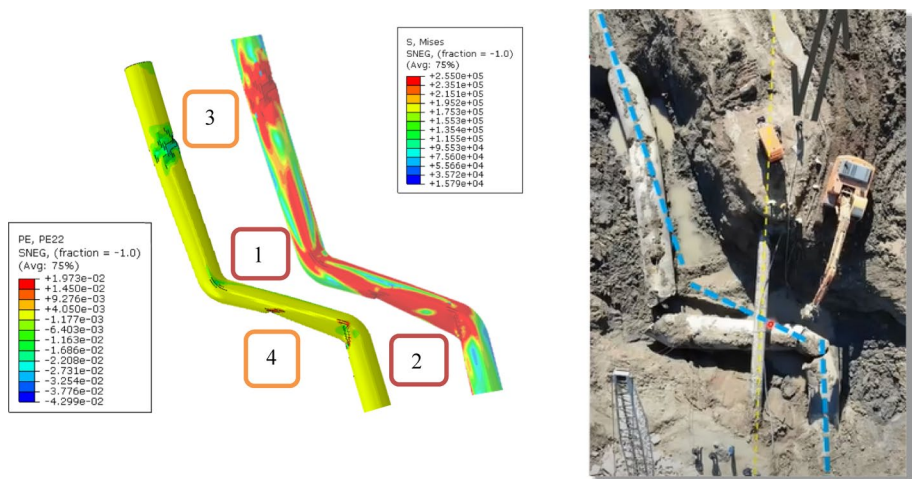
Two major wrinkle points (#1 and #2) were observed with a complete pipe wall tears at elbows as well as two minor wrinkles (#3 and #4) without any wall tearing phenomena (Fig. 22). As these buckles formed, the portion of pipe between wrinkles became a mechanism hence, unloaded. As observed from the figure, the axial displacement and rotation demands are accommodated primarily at the two buckles.

**Fig. 22** Rupture of the elbow sections and the nonlinear numerical model results (von-misses and plastic strain) in comparison with the observed damages of the Gaski–Duzbag water pipe line

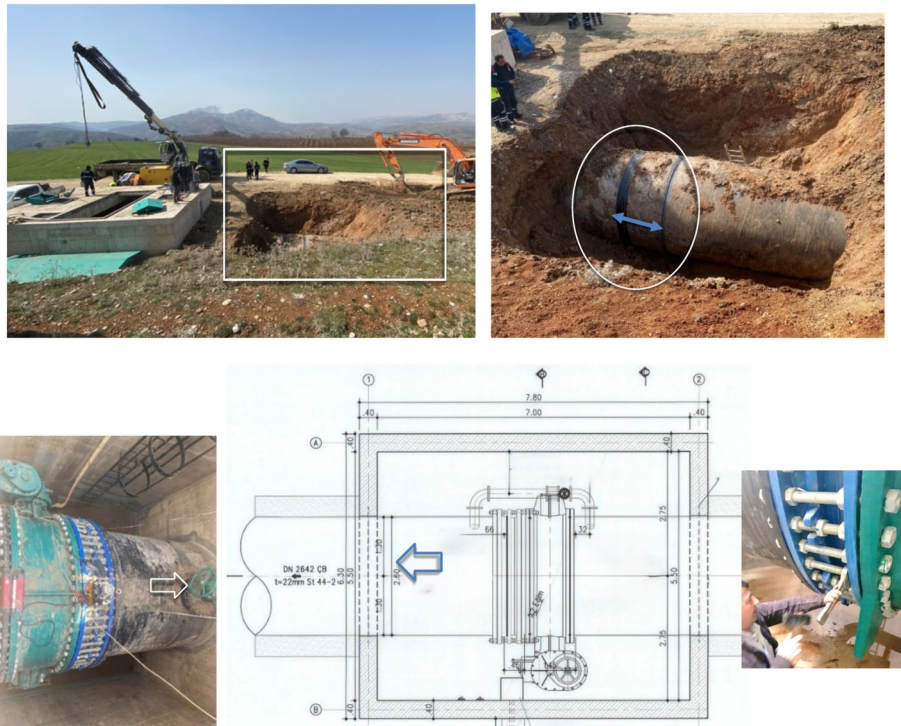
Due to relative movement between the pipe inlet and the valve chamber, axial deformations occurred in the pipe. However, the deformation capacity of the pipe-valve connection (pipe removal joint unit) was insufficient to meet the demand. Initially, the stress in the bolted connections was released. However, it was not sufficient to release the excessive tensile force developed in the pipe. Therefore, the GASKI team decided to relieve the elastic stress accumulated in the pipeline by cutting the pipe at a point close to the valve room as

**Fig. 24** The pull-out phenomenon at the valve room and replacement (stress releasing) of the pipe followed by cutting and welding process

shown in Fig. 24. After the elastic energy in the pipe was released, a 40.0 cm opening in the axial direction occurred in the pipe. This gap was then filled by welding a piece of pipe as shown in Fig. 24.
