# The performance of transmission pipelines on February 6th, 2023 Kahramanmaras earthquake: a series of case studies

E. Uckan<sup>1</sup> · M. Aksel<sup>1,2</sup> · O. Atas<sup>1</sup> · S. Toprak<sup>3</sup> · E. S. Kaya<sup>1,4</sup>

Received: 9 December 2023 / Accepted: 10 June 2024 / Published online: 1 July 2024  
© The Author(s) 2024

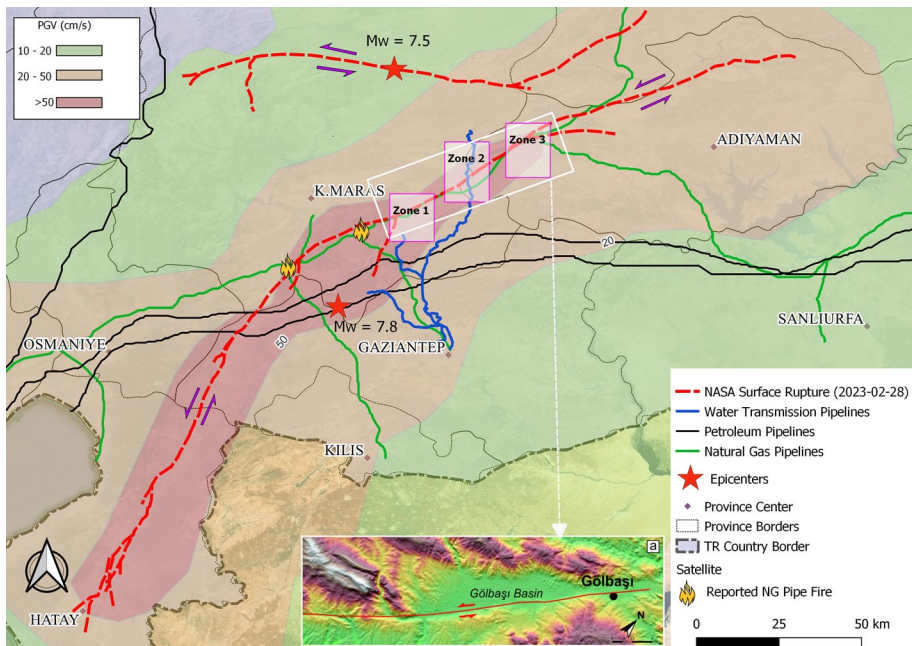
**Fig. 1** The routes of the hydrocarbon and water transmission pipelines, the EAF line, the epicenter of the earthquake, PGV map and geological map of the Golbasi Basin including geomorphology (Yönlü et al. 2017) Zone 1: Hydrocarbon damage, Zone 2: Water line damages Zone 3: Manhole floats due to liquefaction

damage due to fault offsets at different points. Two explosions occurred in the K. Maras-Gaziantep and as a result, gas outages occurred in the cities of Gaziantep and Hatay.

On the other hand, the exact routes of the water line were available. As seen in the figure, Duzbag–Gaziantep water transmission line was crossing the EAF at a single point near Sogutlu village (*Zone 2*). Due to excessive fault offset, the pipeline ruptured and was therefore out of service for several weeks. There were two other functional lines feeding the city. Therefore, the water system remained almost operational, hence water was provided within two days in the city of Gaziantep.

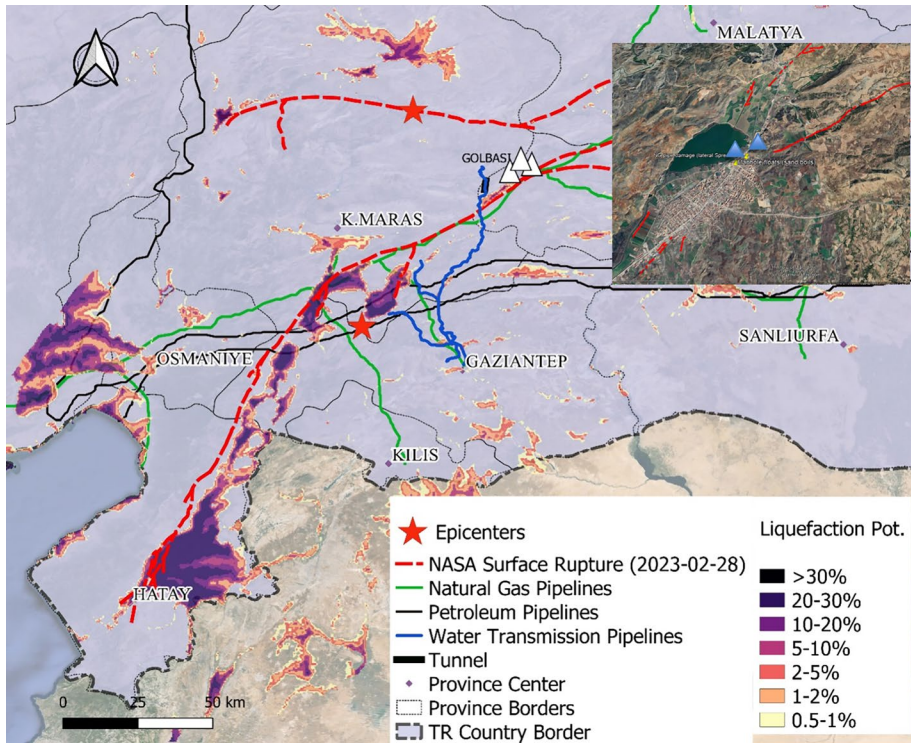
**Fig. 3** Liquefaction potential around the EAF line (National Aeronautics and Space Administration 2023a) manhole floating and NG damage due to liquefaction lateral spreading in Golbasi

fault line, nearby Hatay and Turkoglu. The field reconnaissance survey was mainly conducted in the northern region. Pipe damages were also observed due to liquefaction hazard in the Golbasi region. Detailed information about these damages is provided in the following section.

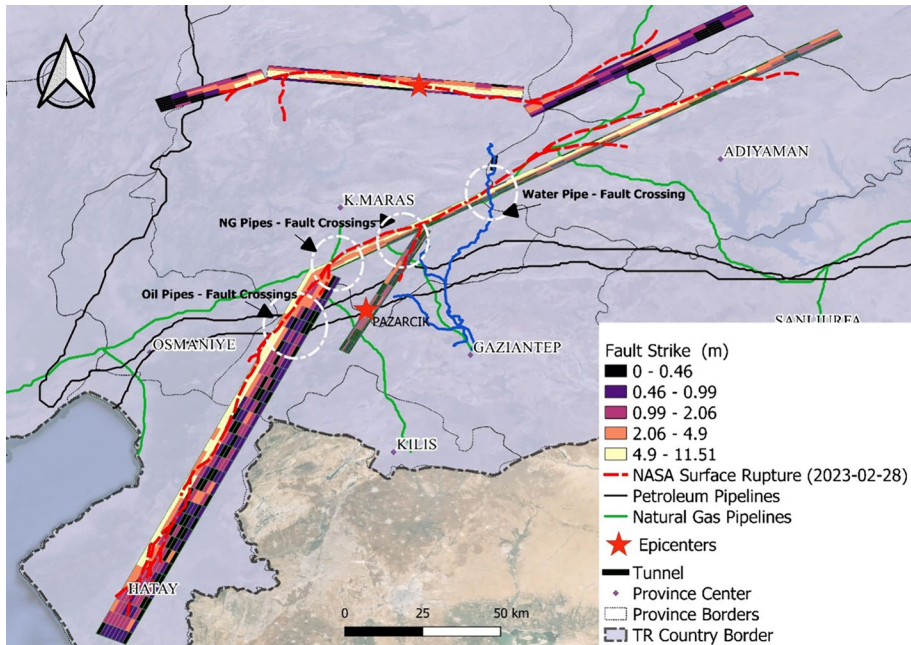
**Fig. 5** Fault crossings of natural gas, crude oil and water pipes overlaid on the PGD map provided from NASA

cross the fault line several times with positive or negative orientation angles as can be seen in Fig. 5. The approximate locations of fault crossings and explosions that caused disruption of NG in Gaziantep were also marked.

Figure 5 shows that the CO pipelines intersect the NE-SW oriented EAF at a single point near Nurdagi. In addition, the two NG lines namely, K. Maras-Gaziantep and K. Maras-Kilis cross the EAF and DAF at two points being consistent with reported explosions.

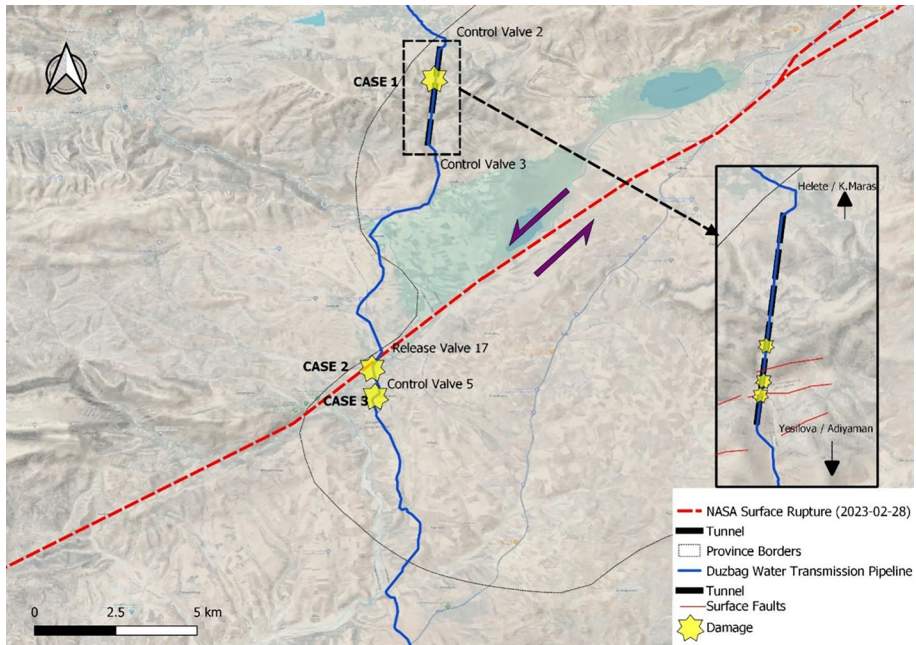
The locations of all three cases are shown in Fig. 10. Case #1 refers to the Duzbag Tunnel Passage whereas Case #2 refers to the Sogutlu fault crossing and Case #3 refers to the pullout of the water pipe at the valve room#5.

**Fig. 10** Damage locations of the Duzbag–Gaziantep transmission line (GASKI 2023)

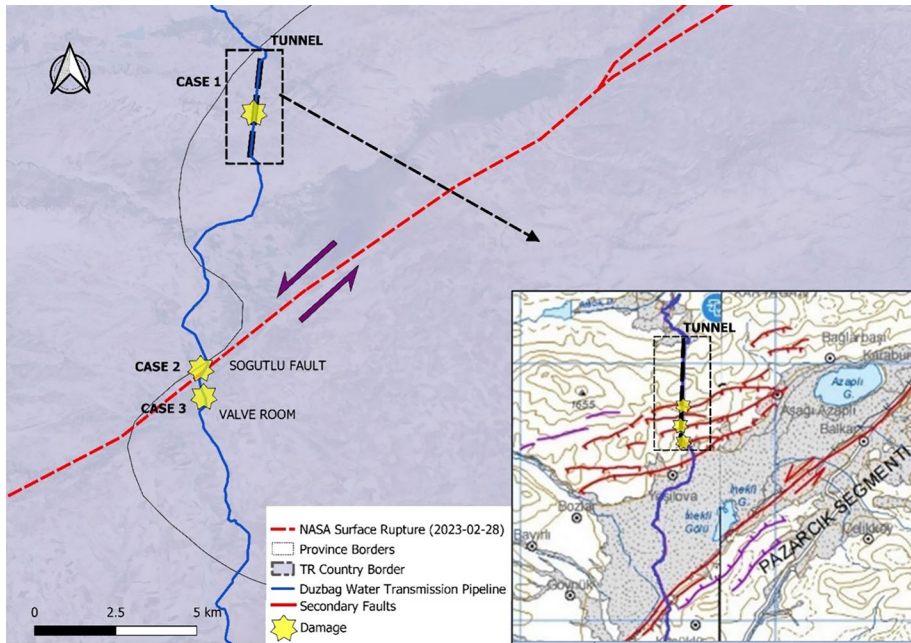
The 3520.0 m long Duzbag tunnel, seen in Fig. 11, is located near Caglayacerit Village of Kahmanmaras. The inner diameter of the tunnel which consists of reinforced concrete lining is 6.3 m. The average depth of the tunnel is 150.0 m, and the deepest part is 300.0 m. As seen in the figure, it is approximately 5.0 km away from the DAF fault and it was under the influence of secondary normal faults that cut its axis perpendicularly as shown in Fig. 11.

**Fig. 11** Damage locations of the Duzbag Tunnel overlaid on secondary normal faults crossing the tunnel axis (background data from MTA (2023))

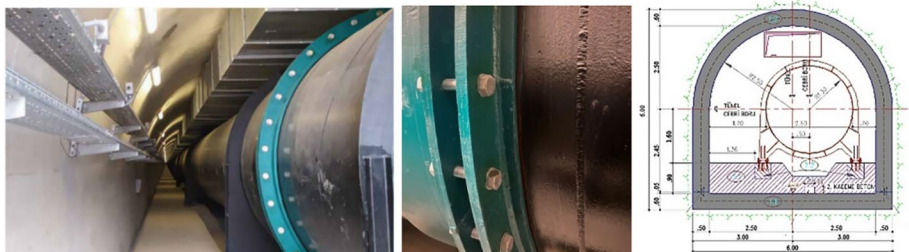
The water transmission pipeline is placed inside the tunnel. It has been converted into a segmented line by flexible couplings and placed freely on the rollers at the bottom of the tunnel. The tunnel-pipe system was exposed to extension due to normal faulting. The axial displacement demand caused by tectonic movement was compensated by sliding supports placed along the axis (Fig. 13).

After the earthquake, the rollers were seen to display about 15.0 cm due to extension of the pipe. However, no damage was observed in the pipeline. On the other hand, the R/C lining, while protecting the pipeline from the tectonic action, was damaged at three points as shown in Fig. 14.

**Fig. 13** The water transmission pipeline inside the tunnel including flexible expansion joints (GASKI 2023)

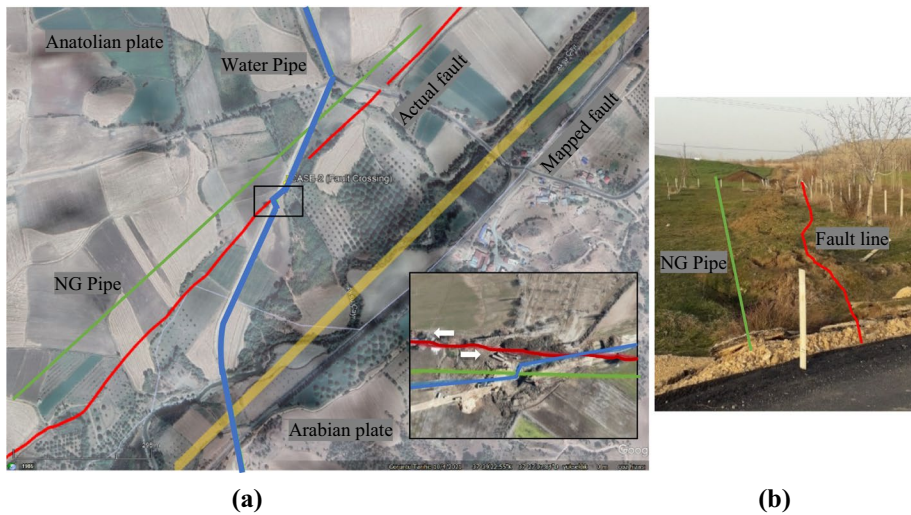
**Fig. 15** **a** The fault-pipe crossing, **b** the orientations of the water (blue), NG pipe (green) and fault line (red), **c** the layout of the pipeline with respect to the fault line (K. Maras, Sogutlu)

The Sogutlu fault crossing can be considered one of the most critical one among all cases mentioned in the previous sections. Figure 15 shows the sketch of pipeline orientations (water and NG) in accordance with the fault line. It was crossing the EAF fault line that ruptured 4.0–5.0 m with an angle of 25 degrees with respect to the pipe axis. Hence the pipeline was subjected to compressive forces due to left lateral slip movement. The NG transmission pipe was also extending parallel to the water pipeline. The pipe was reoriented before the fault crossing by using two pipe bends.

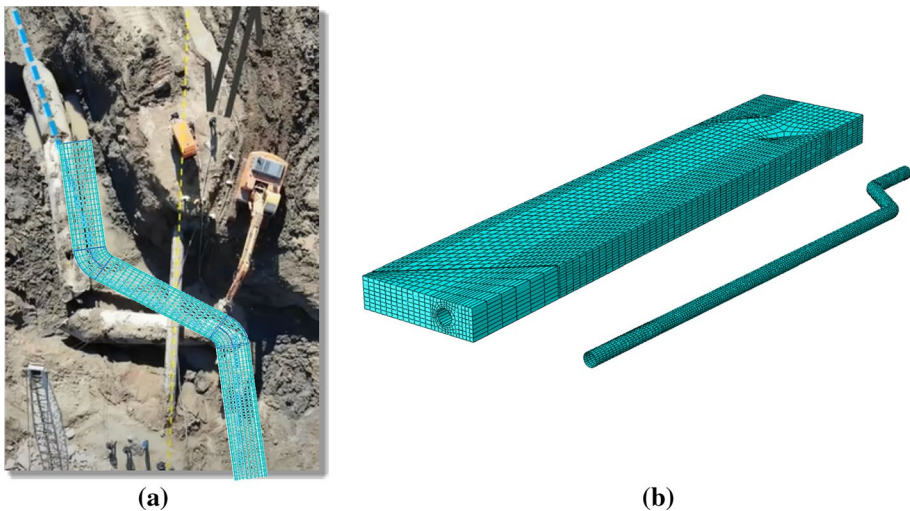
**Fig. 21** **a** Rupture of the Gaski–Duzbag water pipe (meshed pipe depicts the original route) **b** soil–pipe (detached) model used for numerical analyses

Pipe operators confirmed that the undeformed water pipe had 70 degrees of pipe angle before it subjected to the fault motion (depicted using meshed finite element model) and then became around 85 degrees due to permanent ground deformation (Fig. 21). Numerical model has also employed with a ST44 steel grade with 14.0 mm of wall thickness as per

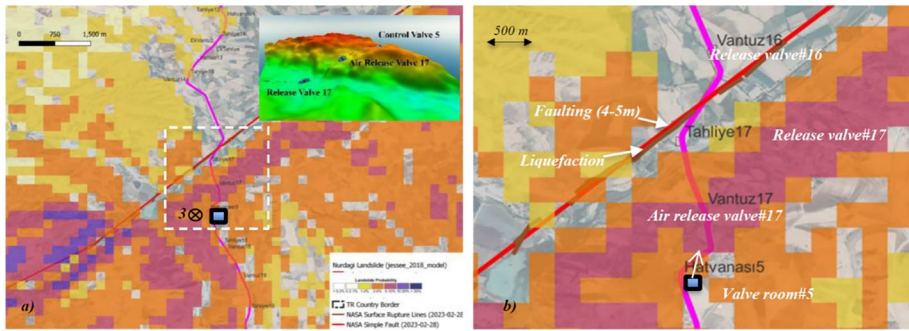
The NASA remote sensing data revealed, liquefaction and faulting effects on the downhill side, about 1 km north of the valve room#5. Since those hazards were far from the area, it is more likely that the pull-out action was caused by the landslide action which took place approximately 200.0 m away from the site as shown in Fig. 23.

**Fig. 23** a Potential land slide zones around b the valve room #5 provided from NASA

Due to relative movement between the pipe inlet and the valve chamber, axial deformations occurred in the pipe. However, the deformation capacity of the pipe-valve connection (pipe removal joint unit) was insufficient to meet the demand. Initially, the stress in the bolted connections was released. However, it was not sufficient to release the excessive tensile force developed in the pipe. Therefore, the GASKI team decided to relieve the elastic stress accumulated in the pipeline by cutting the pipe at a point close to the valve room as
